Property Address: 366 S Conestoga Lp. Palmer, Alaska

Summary

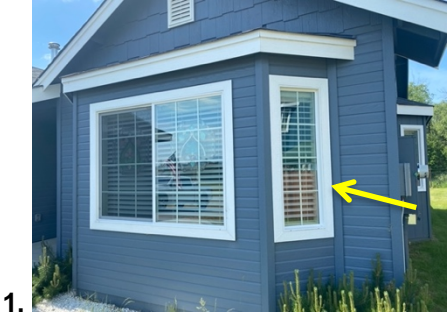
1. The thermal seal in one of the living room windows has been compromised, causing moisture to be trapped between the panes of glass. The window is not as energy efficient and will eventually become foggy, consideration should be given to having the window repaired.
2. The flashing for the back-deck ledger board is missing. I recommend having the flashing installed to prevent the rainwater from being trapped against the siding and causing rot damage.

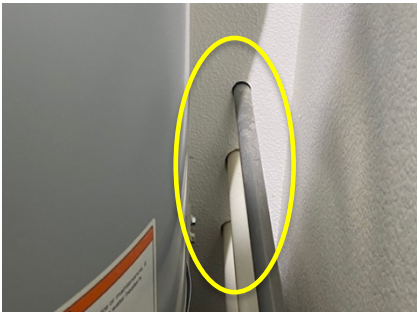
1. The garage-to-house firewall has been compromised by the water and drain lines that go into the garage wall. I recommend having the penetrations sealed with an approved fire-caulking.

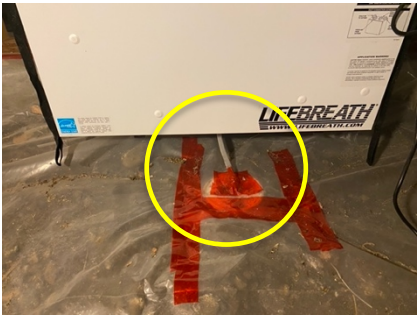
1. The kitchen range hood fan was noisy when it was operated. I recommend having the appliance repaired as needed.
2. The HRV drain line is not plumbed into the house drain line. It is currently installed in a bucket under the vapor barrier in the crawlspace. I recommend having the drain-line re-routed to the furnace condensate pump.

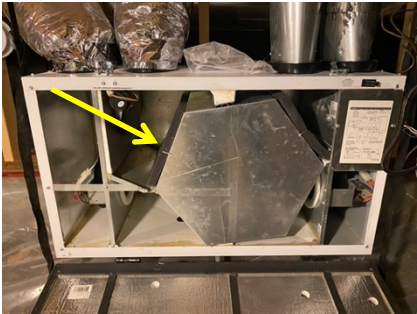
1. The smoke and carbon monoxide detectors should be replaced every 10 years and the batteries should be replaced annually.
2. There is an HRV appliance installed in the crawlspace. Most HRV's have filters that should be cleaned every 3-4 months, a core that should be cleaned every 6-12 months, and an exterior intake that should be cleaned as needed. I recommend following the manufactures maintenance instructions that are posted on the HRV core.

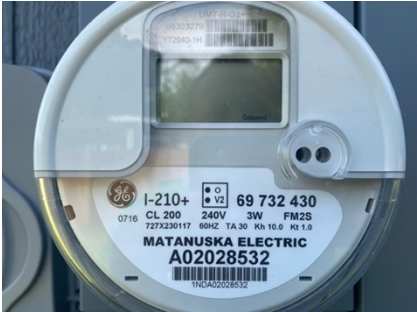
- 1. Attached is a picture of the electric meter.

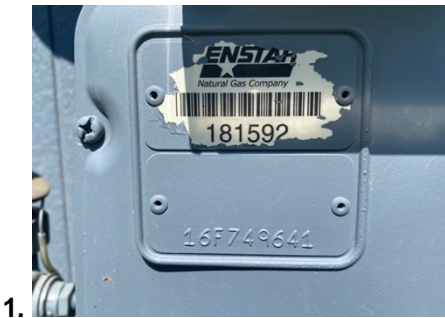
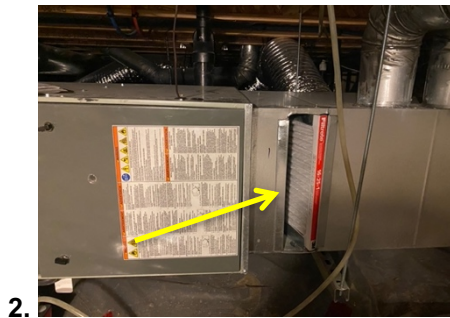
1. Attached is a picture of the gas meter.
2. Attached is a picture of the furnace filter slot. Most filters should be replaced every 3 months, depending on the type of filter that is installed.
3. The heating system functioned at the time of the inspection, however, I recommend having the heating system serviced by a licensed HVAC contractor.

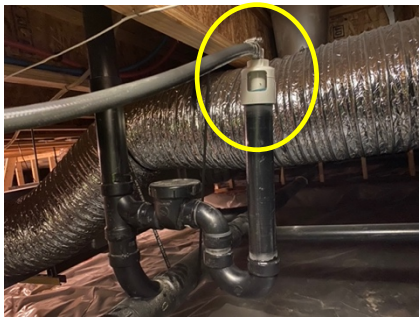
1. There is an open drain line (for the water softener back-flush drain) on the septic system in the crawlspace. If the septic backs up it would dump sewage into the crawlspace. I recommend having the open drain line capped, and the water softener backflush drain, re-routed to a location above the floor of the home by a licensed plumbing contractor.

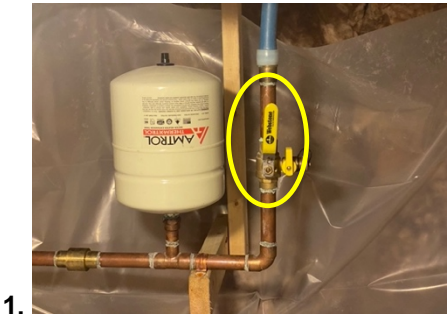
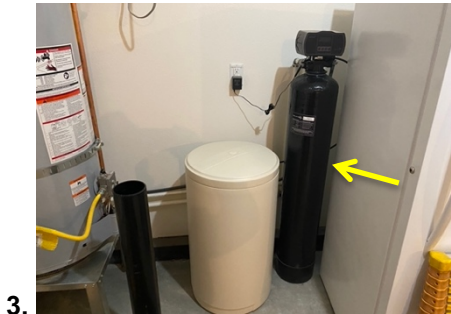
1. Attached is a picture of the main water shut-off valve (yellow) in the crawlspace.
2. The water heater functioned at the time of the inspection, however, I recommend having the appliance serviced by a licensed plumbing contractor.
3. There is a water softener system installed in the garage. I recommend consulting with a licensed water treatment professional to learn how to maintain the appliance.
